Fractured Canine Tooth

Root Canal Therapy

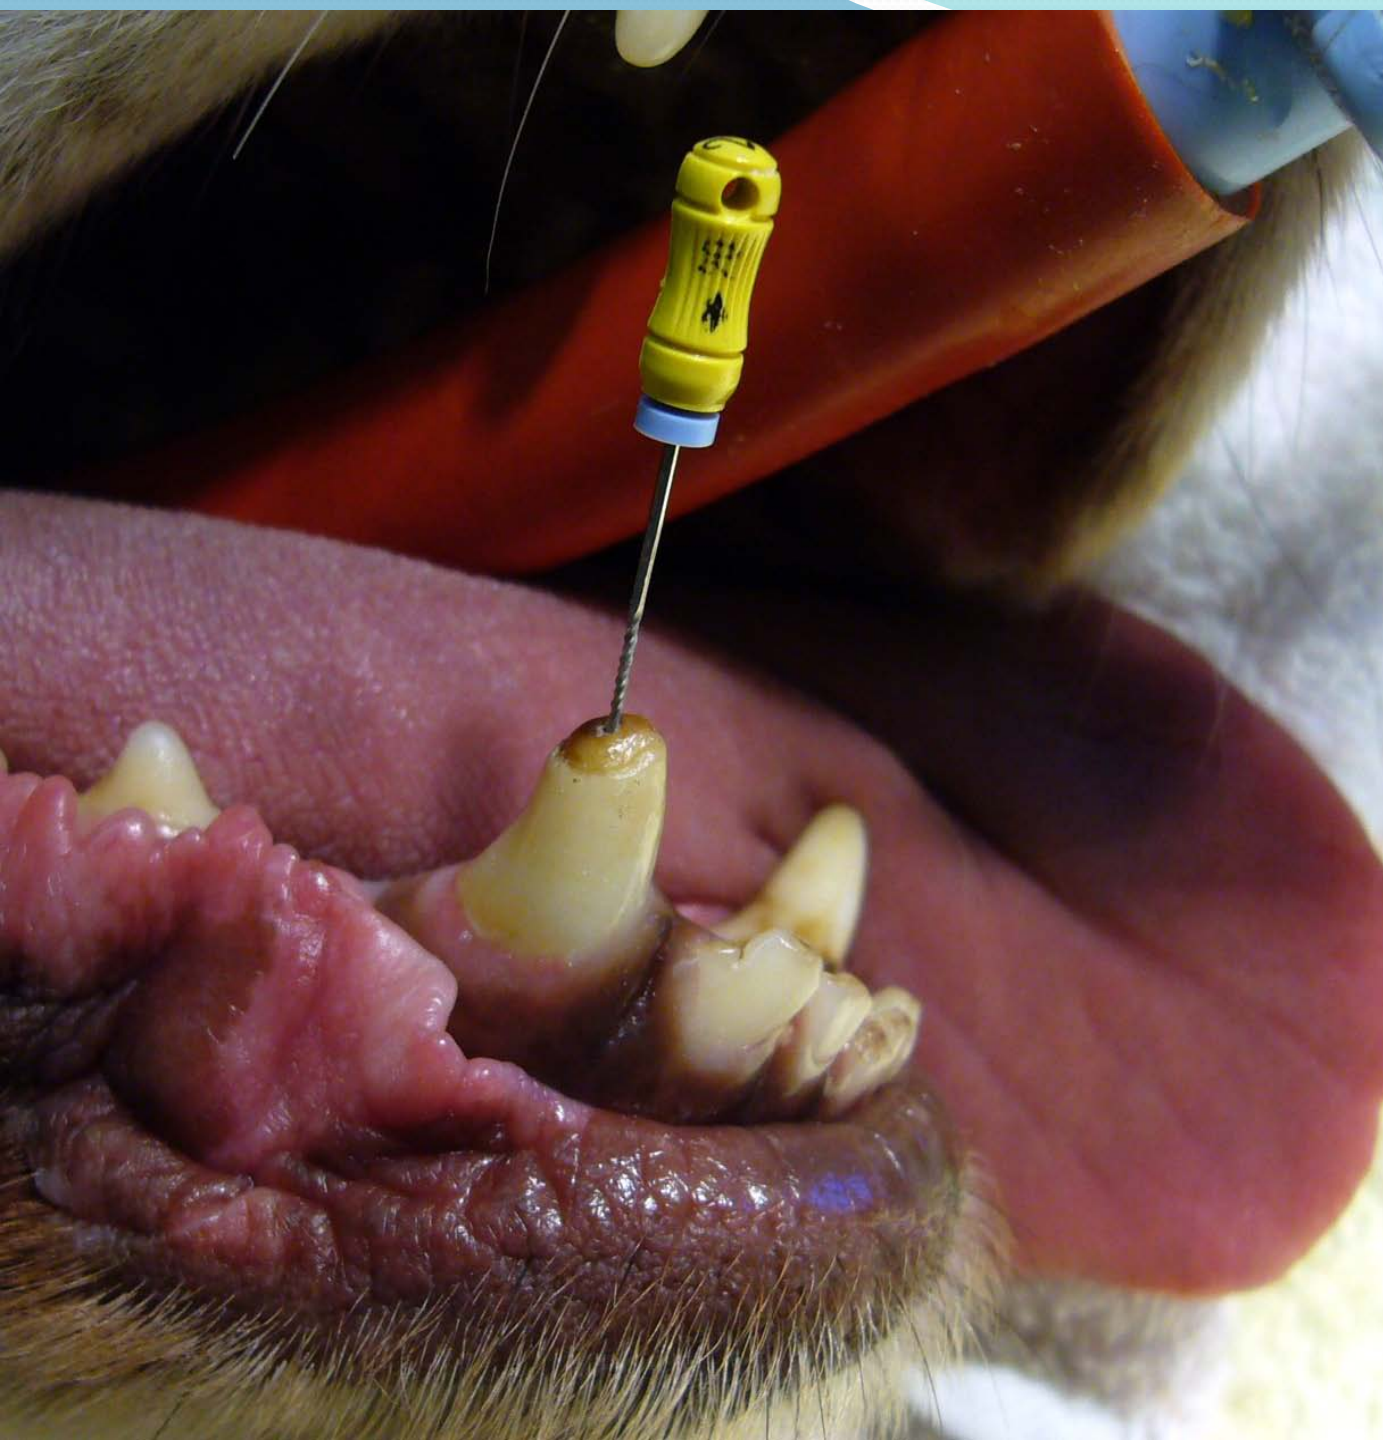
**Fractured
right lower
canine
with
file in
open pulp
access**
